# Access Compliance Report Public Rights-of-Way (Curb Ramps)

Main Street: SILVERWOOD\_DR Cross Street: FOSTER\_RD Location: N

ADA ID: RPAT211202115721 Ramp Type: Type 1 - Perpendicular Diagonal Initial Pass/Fail: Fail Overall Compliance: No Severity Score: 15

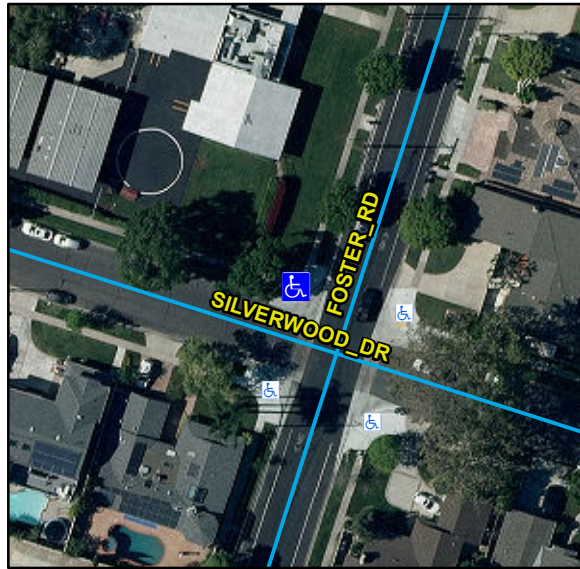
| Compliance | Description | Data | Compliance | Description | Data |
|---|---|---|---|---|---|
| No | Ramp Run Slope (%) | 8.8 | N/A | Flare Slope LT (%) | N/A |

Remove & Replace Curb Ramp With Two New Directional Ramps or Equivalent.

R304.2.2, STD 1115
