Access Compliance Report Public Rights-of-Way (Curb Ramps)

Main Street: FOSTER_RD **Cross Street: SILVERWOOD DR** Location:

ADA ID: RPAT211202120206 Ramp Type:Type 1 - Perpendicular Diagonal Initial Pass/Fail: Pass

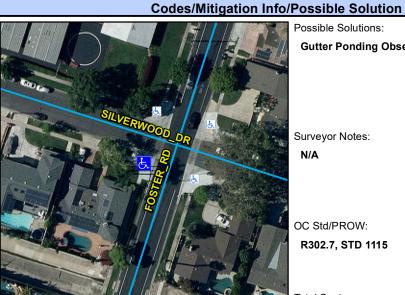
Overall Compliance: No Severity Score:

Possible Solutions: **Gutter Ponding Observed.**

Crossing 1 Direction	SE		Crossing 2 Direction	NE			
D		Marked Crosswalk 1 Width (in)	N/A		Marked Crosswalk 2 Width (in)	120			
ol	N/A	Ramp Inside Crosswalk 1	N/A	Yes	Ramp Inside Crosswalk 2	Yes			
R		Crossing 1 Slope (%)	1.6		Crossing 2 Slope (%)	6.5			
ın		Crossing 1 Cross Slope (%)	0.5		Crossing 2 Cross Slope (%)	0.1			
	No	Gutter Ponding	Yes	Yes	Curb Slope	1.1			
	Yes	Gutter Lip Height (in)	0		Road Run Slope (%)	3.1			
	Yes	Gutter Run Slope (%)	3.3		Road Cross Slope (%)	2.4			
ta a	Yes	Gutter Cross Slope (%)	0.5						
lo	Yes	Overall Surface Condition: Accep	otable	Yes	Perp Joint Present	Yes			
Ά		Cross Gutter Present?	Yes		Spandrel Present?	Yes			
^		Replace Cross Gutter?	No	J	Replace Spandrel?	No

R302.7, STD 1115

Total Cost: 252
