# Access Compliance Report Public Rights-of-Way (Curb Ramps)

Main Street: SILVERWOOD\_DR Cross Street: FOSTER\_RD Location: S

ADA ID: RPAT211202120617 Ramp Type: Type 1 - Perpendicular Diagonal Initial Pass/Fail: Pass Overall Compliance: No Severity Score: 0

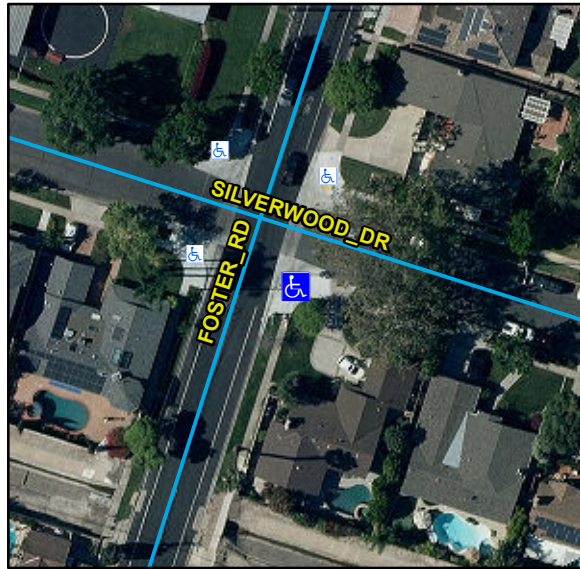
| Compliance | Description | Data | Compliance | Description | Data |
|---|---|---|---|---|---|
| No | Landing Cross Slope (%) | 2.8 | Yes | DWS Provided | Yes |
| No | Gutter Ponding | Yes | No | Curb Slope | 9.8 |
| No | Gutter Cross Slope (%) | 2.1 | | | |

Remove & Replace Curb Ramp With Two New Directional Ramps or Equivalent. Remove & Replace Gutter.
