# Access Compliance Report Public Rights-of-Way (Curb Ramps)

Main Street: FOSTER\_RD Cross Street: SILVERWOOD\_DR Location: E

ADA ID: RPAT211202120950 Ramp Type: Type 1 - Perpendicular Diagonal Initial Pass/Fail: Pass Overall Compliance: No Severity Score: 0

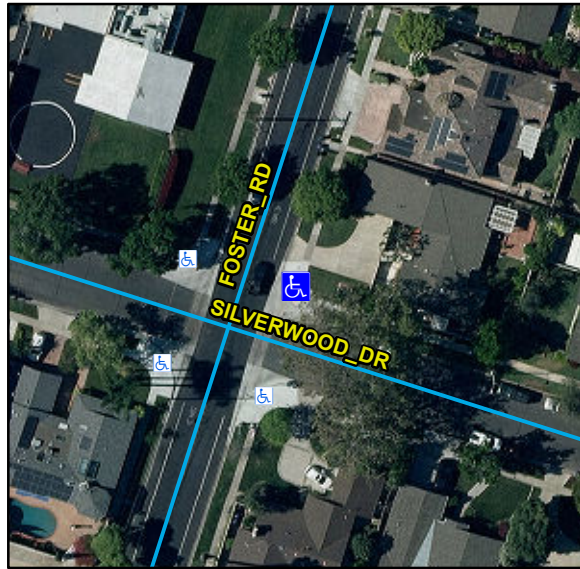
| Compliance | Description | Data | Compliance | Description | Data |
|---|---|---|---|---|---|
| No | Landing Run Slope (%) | 2.4 | N/A | Flare Traversable RT | Yes |

Remove & Replace Landing.

R304.2.2-Perp, R304.3.2-Para, STD 1115
