# Access Compliance Report Public Rights-of-Way (Curb Ramps)

Main Street: SILVERWOOD\_DR Cross Street: DONOVAN\_RD Location: N

ADA ID: RPAT211202121520 Ramp Type: Type 1 - Perpendicular Diagonal Initial Pass/Fail: Fail Overall Compliance: No Severity Score: 16

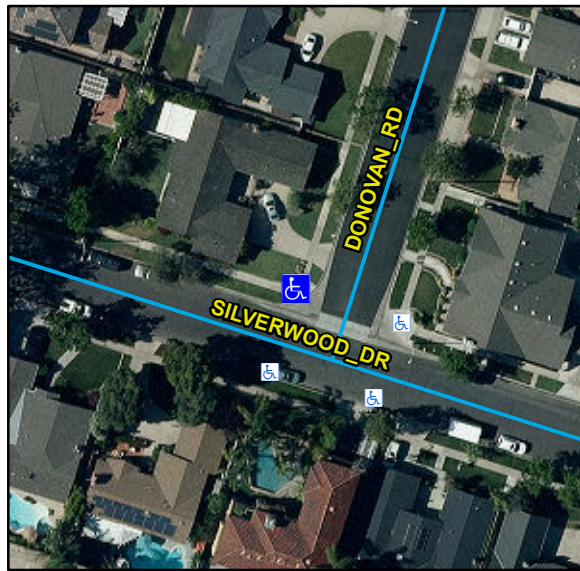
| Compliance | Description | Data | Compliance | Description | Data |
|---|---|---|---|---|---|
| No | Ramp Run Slope (%) | 8.6 | N/A | Flare Slope LT (%) | N/A |

Remove & Replace Curb Ramp With Two New Directional Ramps or Equivalent.

R304.2.2, R204.3, STD 1115
