# Access Compliance Report Public Rights-of-Way (Curb Ramps)

Main Street: SILVERWOOD\_DR Cross Street: BASKERVILLE\_RD Location: N

ADA ID: RPAT211202122233 Ramp Type: Type 1 - Perpendicular Diagonal Initial Pass/Fail: Pass Overall Compliance: No Severity Score: 16

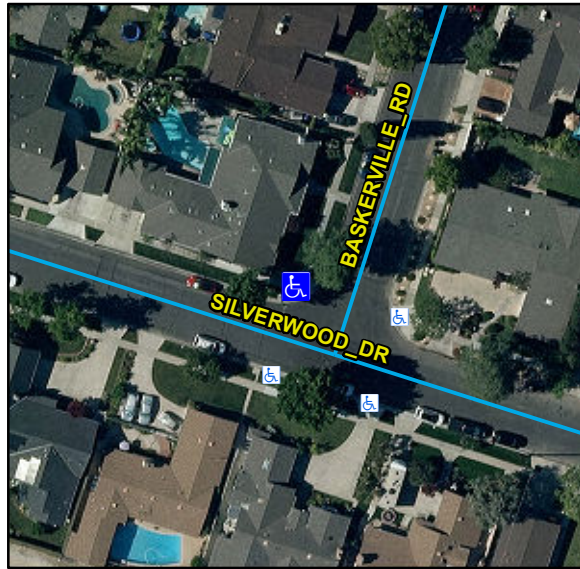
| Compliance | Description | Data | Compliance | Description | Data |
|---|---|---|---|---|---|
| No | Landing Run Slope (%) | 3.7 | N/A | Flare Traversable RT | No |
| Yes | Landing Cross Slope (%) | 1.2 | No | DWS Provided | No |
| No | Gutter Ponding | Yes | Yes | Curb Slope | 3.7 |

Remove & Replace Curb Ramp With Two New Directional Ramps or Equivalent. Gutter Ponding Observed.
