# Access Compliance Report Public Rights-of-Way (Curb Ramps)

Main Street: BASKERVILLE\_RD Cross Street: SILVERWOOD\_DR Location: E

ADA ID: RPAT211202122651 Ramp Type: Type 1 - Perpendicular Diagonal Initial Pass/Fail: Pass Overall Compliance: No Severity Score: 21

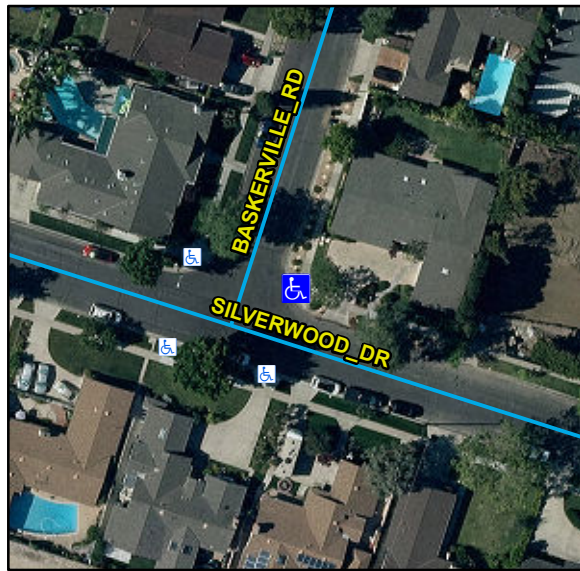
| Compliance | Description | Data | Compliance | Description | Data |
|---|---|---|---|---|---|
| No | Landing Run Slope (%) | 2.5 | N/A | Flare Traversable RT | No |
| Yes | Landing Cross Slope (%) | 1.4 | No | DWS Provided | No |
| Yes | Gutter Ponding | No | No | Curb Slope | 6.5 |
| No | Gutter Run Slope (%) | 5.8 | | Road Cross Slope (%) | 3.9 |

Remove & Replace Curb Ramp With Two New Directional Ramps or Equivalent. Remove & Replace Gutter.
