# Access Compliance Report Public Rights-of-Way (Curb Ramps)

Main Street: BURNEY\_PL Cross Street: BASKERVILLE\_RD Location: S

ADA ID: RPAT211202123203 Ramp Type: Type 1 - Perpendicular Diagonal Initial Pass/Fail: Pass Overall Compliance: No Severity Score: 14

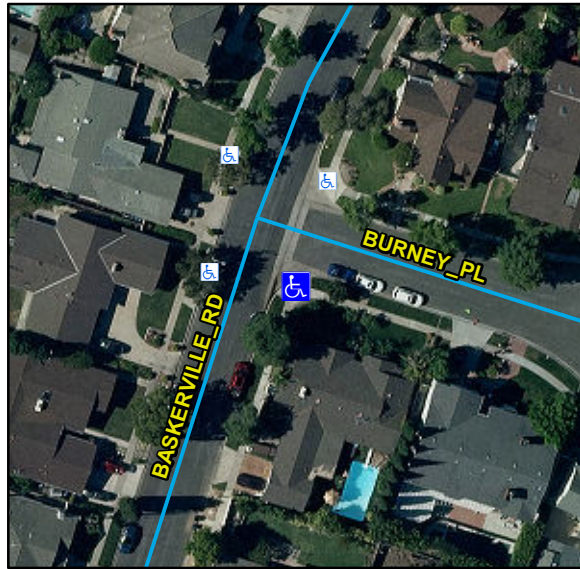
| Compliance | Description | Data | Compliance | Description | Data |
|---|---|---|---|---|---|
| No | Landing Run Slope (%) | 3.6 | N/A | Flare Traversable RT | No |
| Yes | Landing Cross Slope (%) | 1.1 | No | DWS Provided | No |
| No | Gutter Cross Slope (%) | 6 | | | |

Remove & Replace Curb Ramp With Two New Directional Ramps or Equivalent. Remove & Replace Gutter.
