# Access Compliance Report Public Rights-of-Way (Curb Ramps)

Main Street: BASKERVILLE\_RD Cross Street: BURNEY\_PL Location: E

ADA ID: RPAT211202123544 Ramp Type: Type 1 - Perpendicular Diagonal Initial Pass/Fail: Pass Overall Compliance: No Severity Score: 14

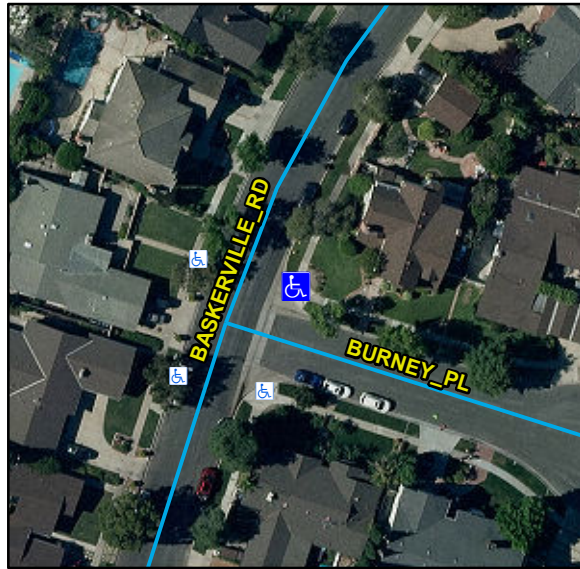
| Compliance | Description | Data | Compliance | Description | Data |
|---|---|---|---|---|---|
| No | Landing Run Slope (%) | 3 | N/A | Flare Traversable RT | No |
| Yes | Landing Cross Slope (%) | 0.8 | No | DWS Provided | No |
| Yes | Gutter Ponding | No | No | Curb Slope | 8.4 |
| No | Gutter Cross Slope (%) | 2.2 | | | |

Remove & Replace Curb Ramp With Two New Directional Ramps or Equivalent. Remove & Replace Gutter.
