# Access Compliance Report Public Rights-of-Way (Curb Ramps)

Main Street: COLERIDGE\_DR Cross Street: FOSTER\_RD Location: N

ADA ID: RPAT211202125524 Ramp Type: Type 1 - Perpendicular Diagonal Initial Pass/Fail: Fail Overall Compliance: No Severity Score: 15

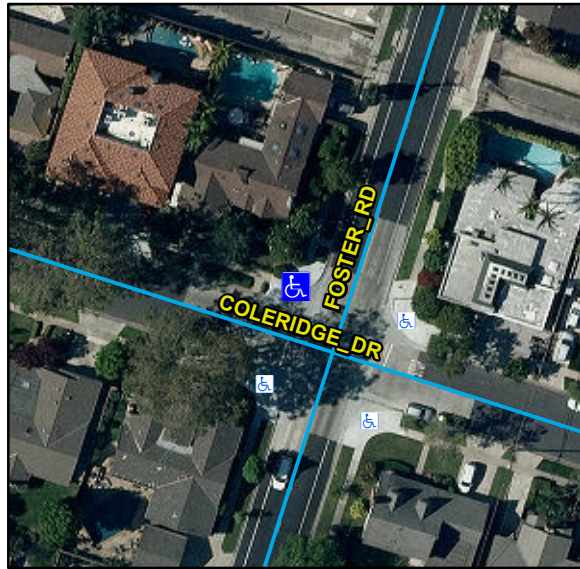
| Compliance | Description | Data | Compliance | Description | Data |
|---|---|---|---|---|---|
| No | Ramp Run Slope (%) | 8.6 | N/A | Flare Slope LT (%) | N/A |

Remove & Replace Curb Ramp With Two New Directional Ramps or Equivalent.

R304.2.2, STD 1115
