# Access Compliance Report Public Rights-of-Way (Curb Ramps)

Main Street: FOSTER\_RD Cross Street: COLERIDGE\_DR Location: W

ADA ID: RPAT211202125843 Ramp Type: Type 1 - Perpendicular Diagonal Initial Pass/Fail: Pass Overall Compliance: No Severity Score: 0

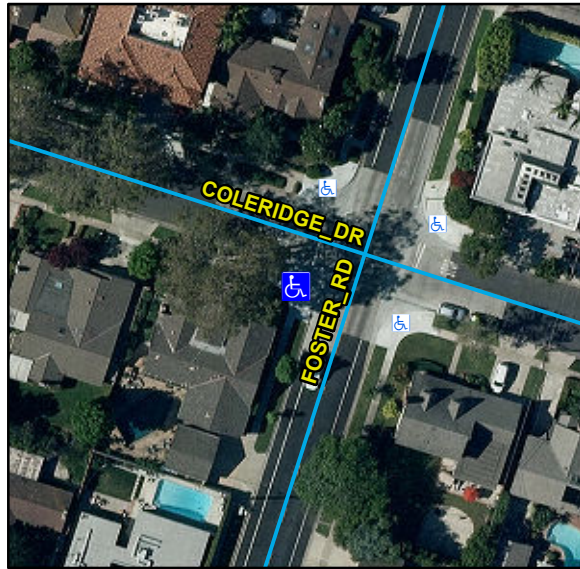
| Compliance | Description | Data | Compliance | Description | Data |
|---|---|---|---|---|---|
| No | Gutter Cross Slope (%) | 2.2 | | | |

Possible Solutions:

Remove & Replace Gutter.

R304.5.3, STD 1115
