# Access Compliance Report Public Rights-of-Way (Curb Ramps)

Main Street: COLERIDGE\_DR Cross Street: FOSTER\_RD Location: S

ADA ID: RPAT211202130329 Ramp Type: Type 1 - Perpendicular Diagonal Initial Pass/Fail: Pass Overall Compliance: No Severity Score: 4

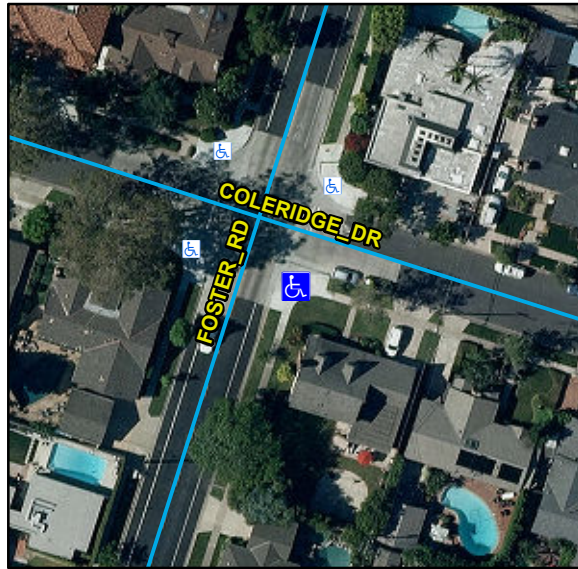
| Compliance | Description | Data | Compliance | Description | Data |
|---|---|---|---|---|---|
| No | Landing Width (in) | 43 | Yes | Flare Slope RT (%) | 6 |

Remove & Replace Landing.

R304.2.1, STD 1115
