# Access Compliance Report Public Rights-of-Way (Curb Ramps)

Main Street: COLERIDGE\_DR Cross Street: WEMBLEY\_RD Location: S

ADA ID: RPAT211202131020 Ramp Type: Type 1 - Perpendicular Diagonal Initial Pass/Fail: Pass Overall Compliance: No Severity Score: 16

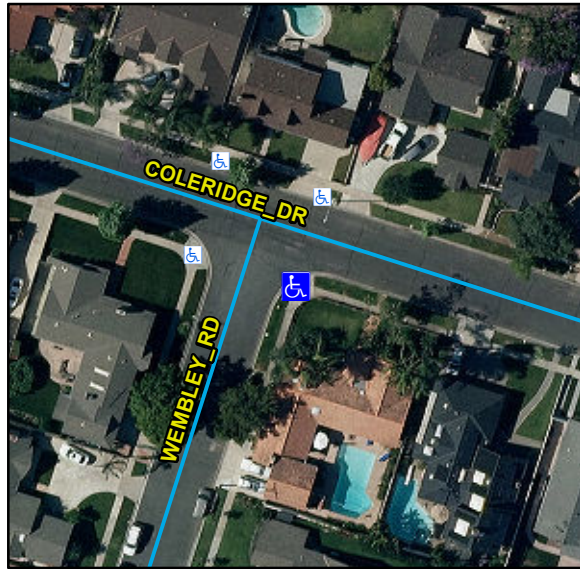
| Compliance | Description | Data | Compliance | Description | Data |
|---|---|---|---|---|---|
| No | Landing Width (in) | 39 | N/A | Flare Slope RT (%) | 5.8 |
| No | Landing Run Slope (%) | 2.3 | N/A | Flare Traversable RT | No |
| No | Landing Cross Slope (%) | 3.7 | No | DWS Provided | No |
| N/A | Landing Movement Obstructed? | Yes | N/A | DWS Contrast | N/A |
| | Landing Movement Type | Wall | N/A | DWS Length (in) | N/A |

Remove & Replace Curb Ramp With Two New Directional Ramps or Equivalent.
