# Access Compliance Report Public Rights-of-Way (Curb Ramps)

Main Street: WEMBLEY\_RD Cross Street: COLERIDGE\_DR Location: W

ADA ID: RPAT211202131415 Ramp Type: Type 1 - Perpendicular Diagonal Initial Pass/Fail: Fail Overall Compliance: No Severity Score: 5

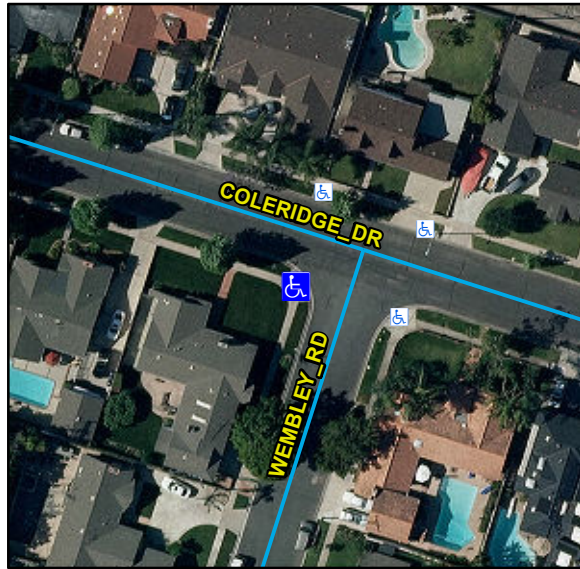
| Compliance | Description | Data | Compliance | Description | Data |
|---|---|---|---|---|---|
| No | Ramp Width (in) | 45 | | | N/A |

Remove & Replace Curb Ramp With Two New Directional Ramps or Equivalent.

R304.2.2, R204.3, R304.5.1, STD 1115

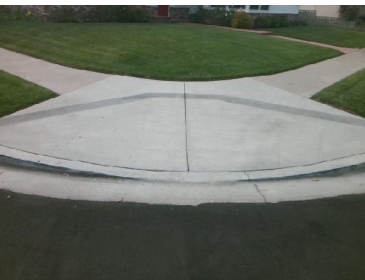
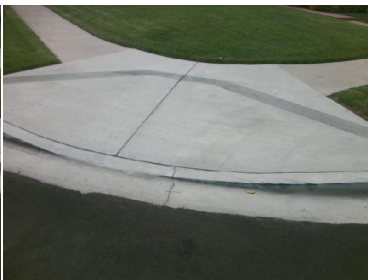
| Compliance | Description | Data | Compliance | Description | Data |
|---|---|---|---|---|---|
| Yes | Overall Surface Condition: Acceptable | | No | Perp Joint Present | No |
