# Access Compliance Report Public Rights-of-Way (Curb Ramps)

Main Street: COLERIDGE\_DR Cross Street: MARTHA\_ANN\_DR Location: S

ADA ID: RPAT211202131857 Ramp Type: Type 1 - Perpendicular Diagonal Initial Pass/Fail: Pass Overall Compliance: No Severity Score: 6

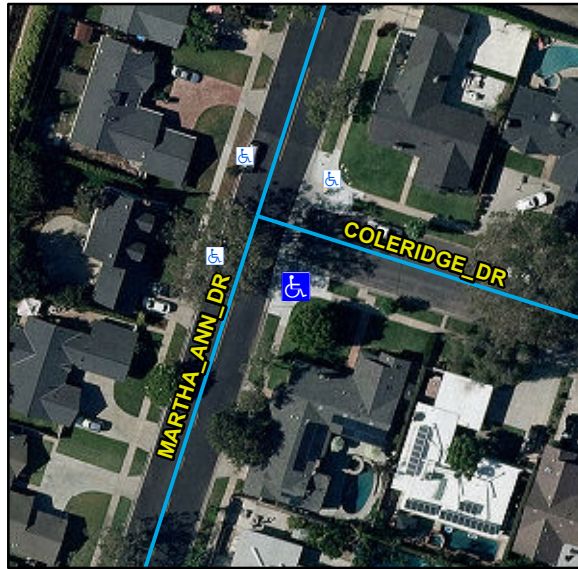
| Compliance | Description | Data | Compliance | Description | Data |
|---|---|---|---|---|---|
| N/A | Landing Present | Yes | N/A | Flare Type RT | |
| N/A | Landing Length (in) | 46 | | | Sloped |
| N/A | Landing Movement Obstructed? | Yes | Yes | DWS Contrast | Yes |
| | Landing Movement Type | Curb | Yes | DWS Length (in) | 36 |

Remove & Replace Landing.

R304.2.1, STD 1115

Total Cost: \$ 531
