# Access Compliance Report Public Rights-of-Way (Curb Ramps)

Main Street: MARTHA\_ANN\_DR Cross Street: COLERIDGE\_DR Location: E

ADA ID: RPAT211202132324 Ramp Type: Type 1 - Perpendicular Diagonal Initial Pass/Fail: Pass Overall Compliance: No Severity Score: 5

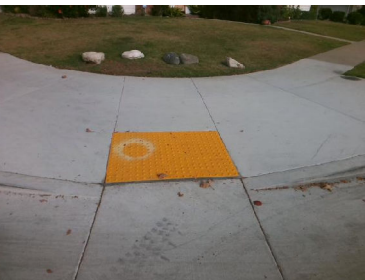
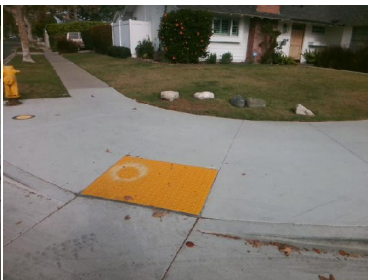
| Compliance | Description | Data | Compliance | Description | Data |
|---|---|---|---|---|---|
| No | Gutter Run Slope (%) | 8.3 | | Road Cross Slope (%) | 3.2 |

Possible Solutions:

Remove & Replace Gutter.
