# Access Compliance Report Public Rights-of-Way (Curb Ramps)

Main Street: NEWBURY\_RD Cross Street: COLERIDGE\_DR Location: W

ADA ID: RPAT211202134148 Ramp Type: Type 1 - Perpendicular Diagonal Initial Pass/Fail: Fail Overall Compliance: No Severity Score: 15

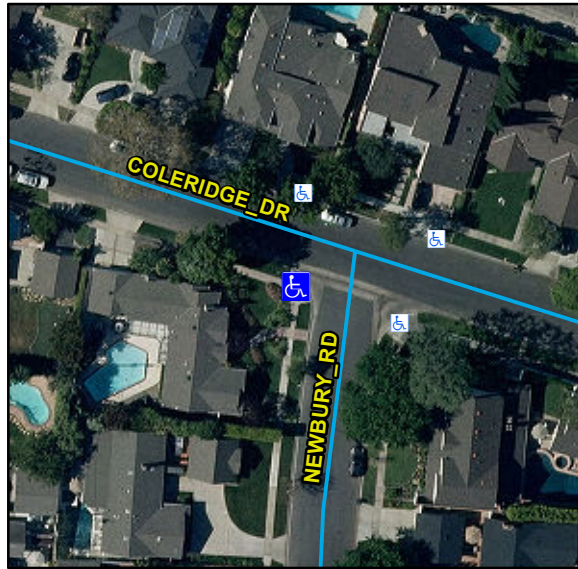
| Compliance | Description | Data | Compliance | Description | Data |
|---|---|---|---|---|---|
| No | Ramp Run Slope (%) | 8.5 | N/A | Flare Slope LT (%) | N/A |

Remove & Replace Curb Ramp With Two New Directional Ramps or Equivalent.
