# Access Compliance Report Public Rights-of-Way (Curb Ramps)

Main Street: COLERIDGE\_DR Cross Street: NEWBURY\_RD Location: S

ADA ID: RPAT211202134435 Ramp Type: Type 1 - Perpendicular Diagonal Initial Pass/Fail: Pass Overall Compliance: No Severity Score: 8

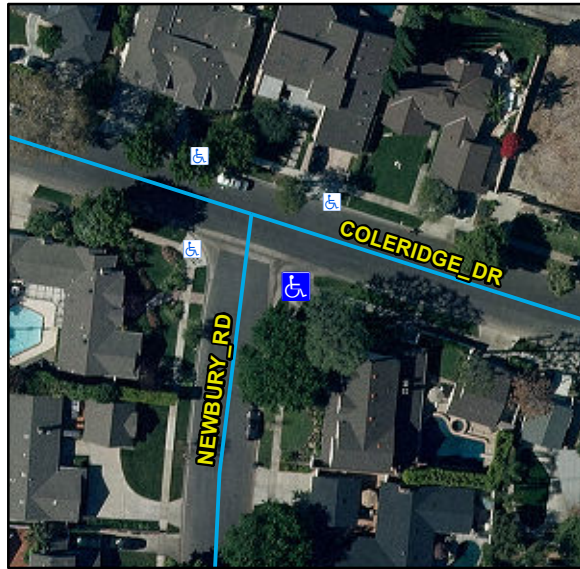
| Compliance | Description | Data | Compliance | Description | Data |
|---|---|---|---|---|---|
| No | Landing Run Slope (%) | 2.6 | N/A | Flare Traversable RT | No |
| Yes | Gutter Ponding | No | No | Curb Slope | 6.2 |

Remove & Replace Curb Ramp With Two New Directional Ramps or Equivalent.
