# Access Compliance Report Public Rights-of-Way (Curb Ramps)

Main Street: GLENROY\_PL Cross Street: SILVER\_FOX\_RD Location: NW

ADA ID: RPAT211202143507 Ramp Type: Type 1 - Perpendicular Diagonal Initial Pass/Fail: Fail Overall Compliance: No Severity Score: 2

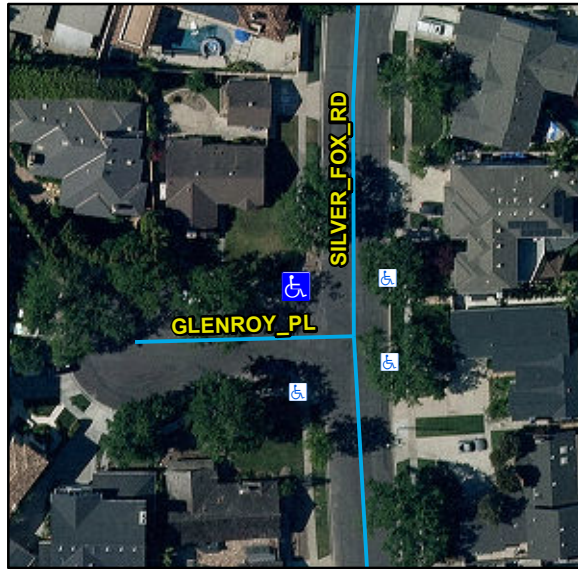
| Compliance | Description | Data | Compliance | Description | Data |
|---|---|---|---|---|---|
| No | Ramp Cross Slope (%) | 2.3 | N/A | Flare Traversable LT | N/A |

Remove & Replace Curb Ramp With Two New Directional Ramps or Equivalent.

R304.2.2, R204.3, R304.5.3, STD 1115

Total Cost: \$ 6160
