# Access Compliance Report Public Rights-of-Way (Curb Ramps)

Main Street: SILVER\_FOX\_RD Cross Street: GLENROY\_PL Location: SW

ADA ID: RPAT211202143744 Ramp Type: Type 1 - Perpendicular Diagonal Initial Pass/Fail: Pass Overall Compliance: No Severity Score: 16

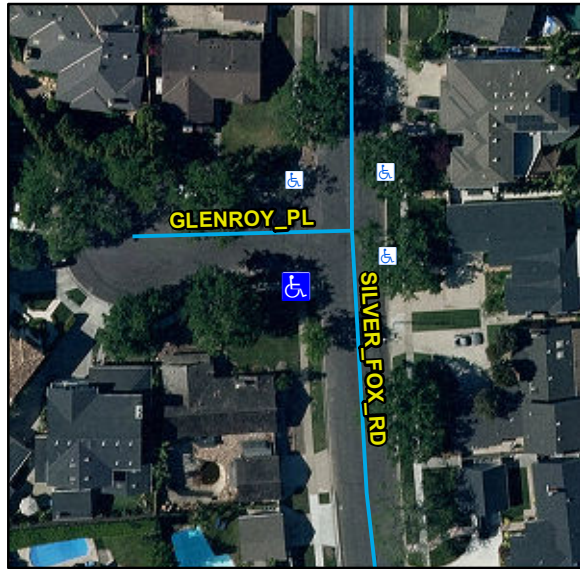
| Compliance | Description | Data | Compliance | Description | Data |
|---|---|---|---|---|---|
| No | Landing Cross Slope (%) | 3.1 | No | DWS Provided | No |
| No | Gutter Ponding | Yes | No | Curb Slope | 7.6 |

Remove & Replace Curb Ramp With Two New Directional Ramps or Equivalent.
