# Access Compliance Report Public Rights-of-Way (Curb Ramps)

Main Street: EDGELEY\_PL Cross Street: SILVER\_FOX\_RD Location: NW

ADA ID: RPAT211202144305 Ramp Type: Type 1 - Perpendicular Diagonal Initial Pass/Fail: Pass Overall Compliance: No Severity Score: 16

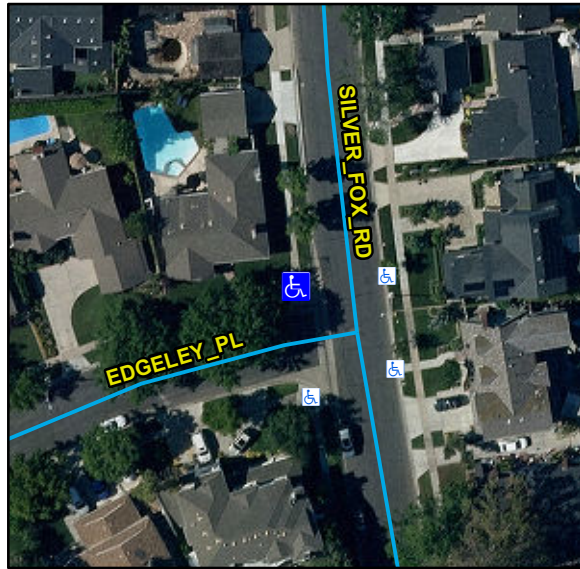
| Compliance | Description | Data | Compliance | Description | Data |
|---|---|---|---|---|---|
| Yes | Landing Cross Slope (%) | 1 | No | DWS Provided | No |
| Yes | Gutter Ponding | No | No | Curb Slope | 8.4 |

Remove & Replace Curb Ramp With Two New Directional Ramps or Equivalent.
