# Access Compliance Report Public Rights-of-Way (Curb Ramps)

Main Street: SILVER\_FOX\_RD Cross Street: EDGELEY\_PL Location: SW

ADA ID: RPAT211202144638 Ramp Type: Type 1 - Perpendicular Diagonal Initial Pass/Fail: Fail Overall Compliance: No Severity Score: 15

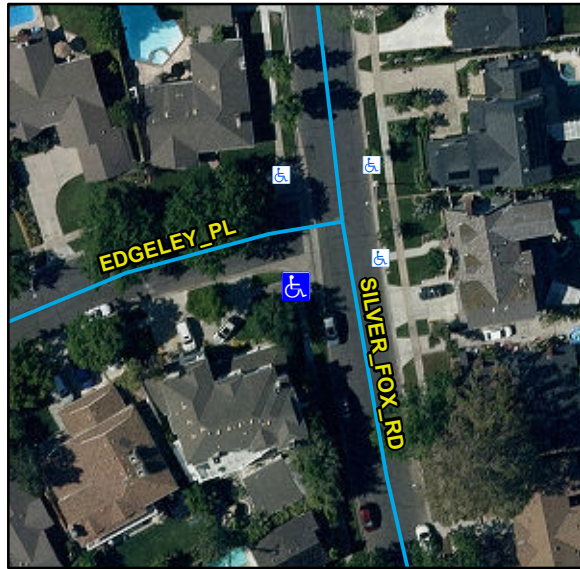
| Compliance | Description | Data | Compliance | Description | Data |
|---|---|---|---|---|---|
| No | Ramp Run Slope (%) | 9.6 | N/A | Flare Slope LT (%) | N/A |

Remove & Replace Curb Ramp With Two New Directional Ramps or Equivalent.

R304.2.2, R204.3, STD 1115
