# Access Compliance Report Public Rights-of-Way (Curb Ramps)

Main Street: ACECA\_DR Cross Street: SILVER\_FOX\_RD Location: NW

ADA ID: RPAT211202145023 Ramp Type: Type 1 - Perpendicular Diagonal Initial Pass/Fail: Fail Overall Compliance: No Severity Score: 16

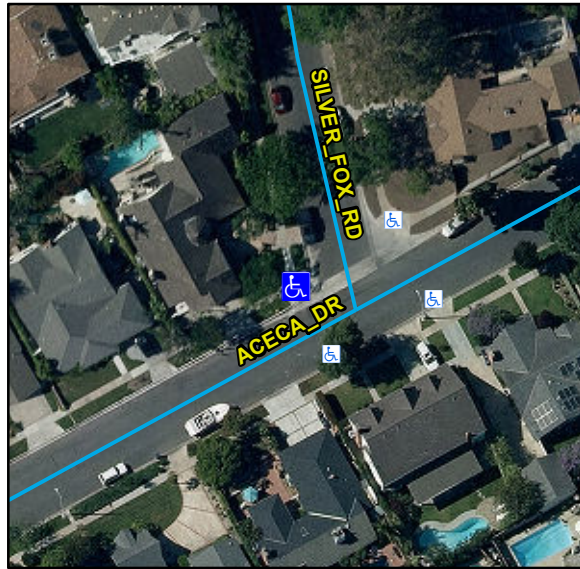
| Compliance | Description | Data | Compliance | Description | Data |
|---|---|---|---|---|---|
| No | Ramp Run Slope (%) | 9 | N/A | Flare Slope LT (%) | N/A |

Remove & Replace Curb Ramp With Two New Directional Ramps or Equivalent.
