# Access Compliance Report Public Rights-of-Way (Curb Ramps)

Main Street: SILVER\_FOX\_RD Cross Street: ACECA\_DR Location: NE

ADA ID: RPAT211202145307 Ramp Type: Type 1 - Perpendicular Diagonal Initial Pass/Fail: Fail Overall Compliance: No Severity Score: 2

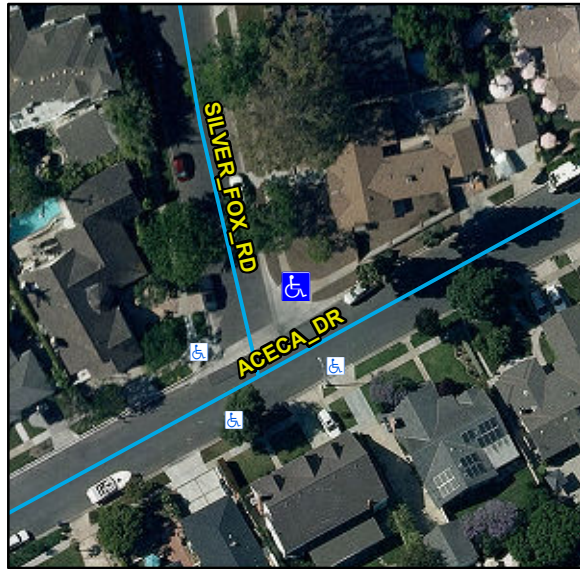
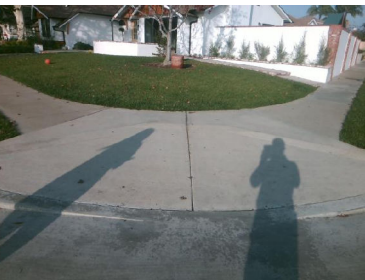
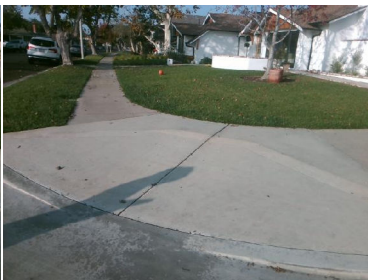
| Compliance | Description | Data | Compliance | Description | Data |
|---|---|---|---|---|---|
| No | Ramp Cross Slope (%) | 3.5 | N/A | Flare Traversable LT | N/A |

Remove & Replace Curb Ramp With Two New Directional Ramps or Equivalent.

R204.3, R304.5.3, STD 1115
