# Access Compliance Report Public Rights-of-Way (Curb Ramps)

Main Street: ARGYLE\_DR Cross Street: PIEDMONT\_AVE Location: E

ADA ID: RPAT211206103514 Ramp Type: Type 1 - Perpendicular Diagonal Initial Pass/Fail: Pass Overall Compliance: No Severity Score: 4

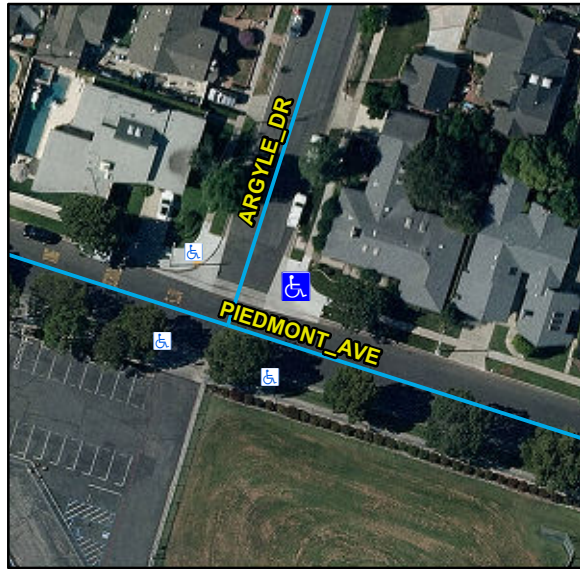
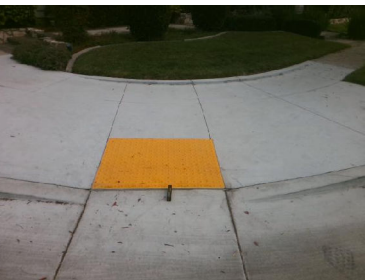
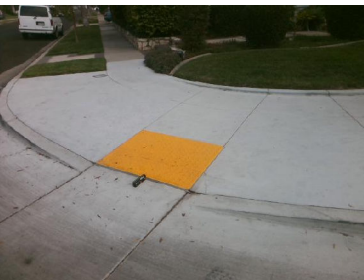
| Compliance | Description | Data | Compliance | Description | Data |
|---|---|---|---|---|---|
| N/A | Landing Length (in) | 41 | | | Sloped |
| N/A | Landing Movement Obstructed? | Yes | Yes | DWS Contrast | Yes |
| | Landing Movement Type | Curb | Yes | DWS Length (in) | 36 |

Possible Solutions:

Remove & Replace Landing.

R304.2.1, STD 1115
