# Access Compliance Report Public Rights-of-Way (Curb Ramps)

Main Street: **PIEDMONT\_AVE** Cross Street: **ARGYLE\_DR** Location: **SE**

ADA ID: **RPAT211206104621** Ramp Type: **Type 1 - Perpendicular** Initial Pass/Fail: **Pass** Overall Compliance: **No** Severity Score: **12**

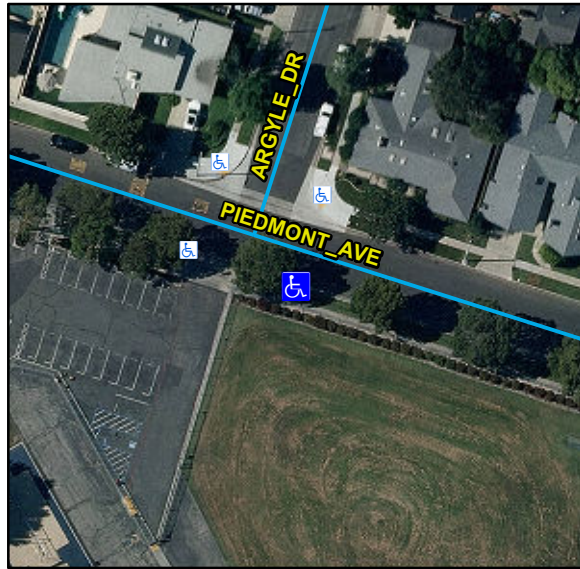
**Unable to collect gutter info due to mud**

| Compliance | Description | Data | Compliance | Description | Data |
|---|---|---|---|---|---|
| <b>No</b> | Landing Run Slope (%) | <b>3.5</b> | <b>N/A</b> | Flare Traversable RT | <b>No</b> |
| <b>No</b> | Gutter Ponding | <b>Yes</b> | <b>N/A</b> | Curb Slope | <b>-9999</b> |

**Remove & Replace Entire Ramp. Remove & Replace Gutter.**
