# Access Compliance Report Public Rights-of-Way (Curb Ramps)

Main Street: **PIEDMONT\_AVE** Cross Street: **ARGYLE\_DR** Location: **N**

ADA ID: **RPAT211206105020** Ramp Type: **Type 1 - Perpendicular Diagonal** Initial Pass/Fail: **Pass** Overall Compliance: **No** Severity Score: **0**

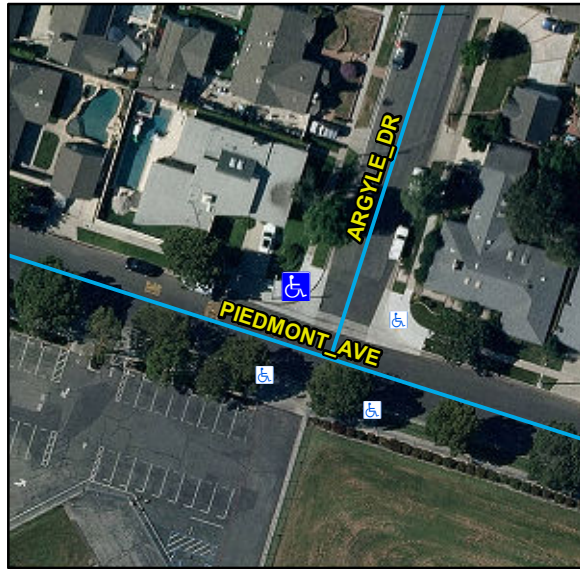
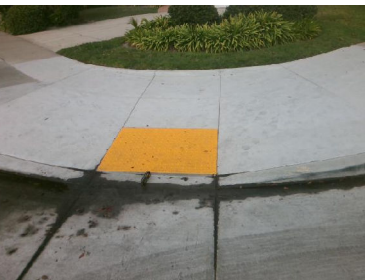
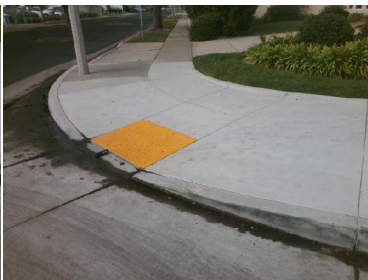
| Compliance | Description | Data | Compliance | Description | Data |
|---|---|---|---|---|---|
| <b>N/A</b> | Landing Length (in) | <b>48</b> | | | <b>Sloped</b> |
| <b>N/A</b> | Landing Movement Obstructed? | <b>Yes</b> | <b>Yes</b> | DWS Contrast | <b>Yes</b> |
| | Landing Movement Type | <b>Curb</b> | <b>Yes</b> | DWS Length (in) | <b>36</b> |

**Remove & Replace Landing.**

**R304.2.1, STD 1115**
