# Access Compliance Report Public Rights-of-Way (Curb Ramps)

Main Street: WEMBLEY\_RD Cross Street: PIEDMONT\_AVE Location: E

ADA ID: RPAT211206105616 Ramp Type: Type 1 - Perpendicular Diagonal Initial Pass/Fail: Pass Overall Compliance: No Severity Score: 14

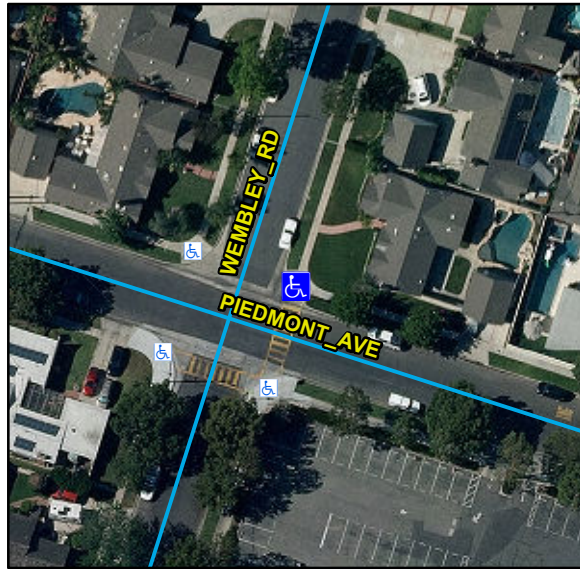
R304.2.2, R204.3, R304.2.1, R305, STD 1115

| Compliance | Description | Data | Compliance | Description | Data |
|---|---|---|---|---|---|
| Yes | Landing Cross Slope (%) | 1.3 | No | DWS Provided | No |
| Yes | Gutter Ponding | No | No | Curb Slope | 9 |

Remove & Replace Curb Ramp With Two New Directional Ramps or Equivalent.
