# Access Compliance Report Public Rights-of-Way (Curb Ramps)

Main Street: **PIEDMONT\_AVE** Cross Street: **WEMBLEY\_RD** Location: **N**

ADA ID: **RPAT211206105918** Ramp Type: **Type 1 - Perpendicular Diagonal Initial Pass/Fail: Fail** Overall Compliance: **No** Severity Score: **15**

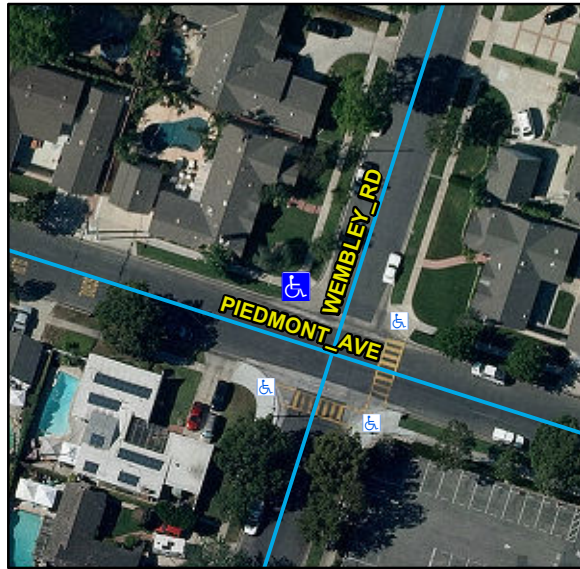
| Compliance | Description | Data | Compliance | Description | Data |
|---|---|---|---|---|---|
| No | Ramp Run Slope (%) | 8.5 | N/A | Flare Slope LT (%) | N/A |

**Remove & Replace Curb Ramp With Two New Directional Ramps or Equivalent.**

**R304.2.2, R204.3, STD 1115**
