# Access Compliance Report Public Rights-of-Way (Curb Ramps)

Main Street: KENSINGTON\_RD Cross Street: PIEDMONT\_AVE Location: E

ADA ID: RPAT211206110258 Ramp Type: Type 1 - Perpendicular Diagonal Initial Pass/Fail: Fail Overall Compliance: No Severity Score: 19

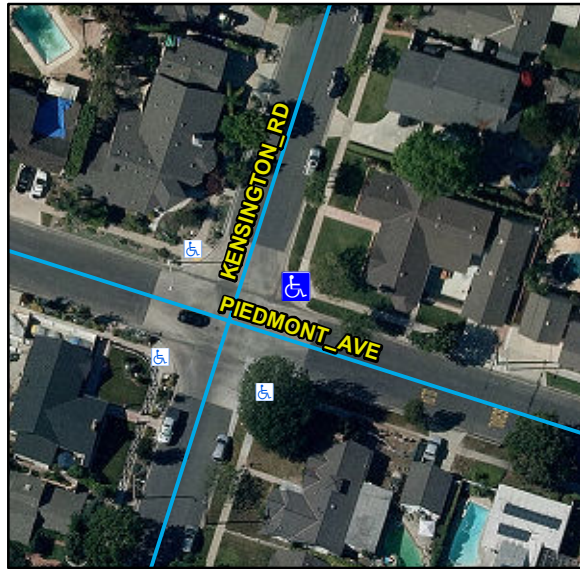
| Compliance | Description | Data | Compliance | Description | Data |
|---|---|---|---|---|---|
| N/A | Ramp Length (in) | 83 | N/A | Flare Type LT | |
| No | Ramp Width (in) | 47 | | | N/A |
| No | Ramp Run Slope (%) | 9.4 | N/A | Flare Slope LT (%) | N/A |
| N/A | Gutter Ponding | N/A | No | Curb Slope | 11.2 |

Remove & Replace Curb Ramp With Two New Directional Ramps or Equivalent.

R304.2.2, R204.3, R304.5.1, STD 1115
