# Access Compliance Report Public Rights-of-Way (Curb Ramps)

Main Street: **PIEDMONT\_AVE** Cross Street: **KENSINGTON\_RD** Location: **N**

ADA ID: **RPAT211206110457** Ramp Type: **Type 1 - Perpendicular Diagonal** Initial Pass/Fail: **Fail** Overall Compliance: **No** Severity Score: **5**

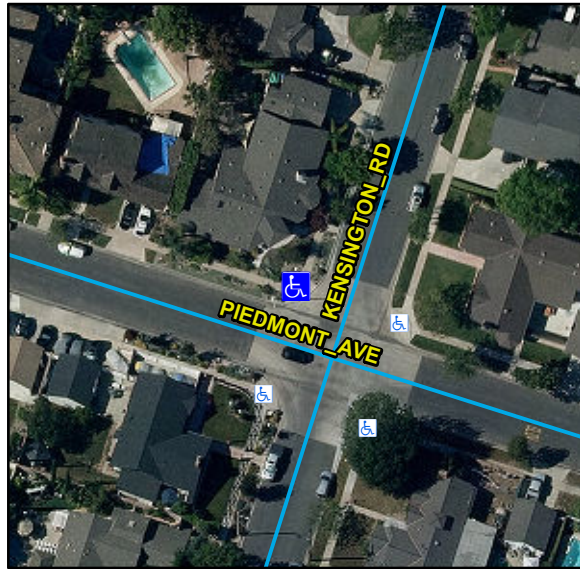
| Compliance | Description | Data | Compliance | Description | Data |
|---|---|---|---|---|---|
| <b>No</b> | Ramp Width (in) | <b>47</b> | | | <b>N/A</b> |

**Remove & Replace Curb Ramp With Two New Directional Ramps or Equivalent.**

**R304.2.2, R204.3, R304.5.1, STD 1115**

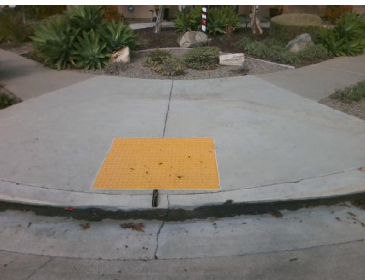
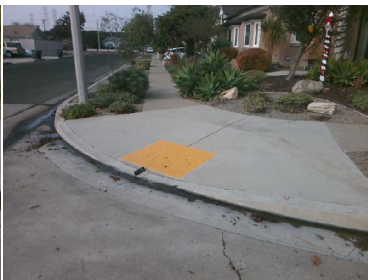
| Compliance | Description | Data | Compliance | Description | Data |
|---|---|---|---|---|---|
| <b>N/A</b> | Gutter Ponding | <b>N/A</b> | <b>No</b> | Curb Slope | <b>9.4</b> |
