# Access Compliance Report Public Rights-of-Way (Curb Ramps)

| Main Street: MARTHA_ANN_DR | | Cross Street: PIEDMONT_AVE | | Location: | E |
| ADA ID: RPAT211206110816 | Ramp Type:Type 1 - Perpendicular Diagonal Initial Pass/Fail: Fail | | Overall Compliance: No | Severity Score: | 15 |

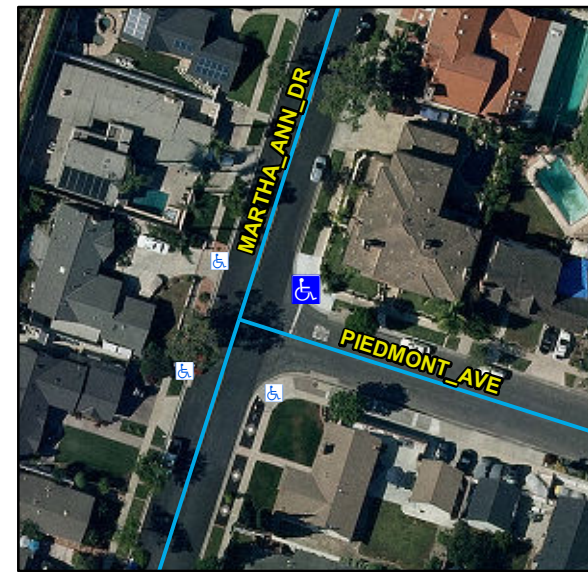
| Compliance | Description | Data | Compliance | Description | Data |
|---|---|---|---|---|---|
| No | Ramp Run Slope (%) | 8.4 | N/A | Flare Slope LT (%) | N/A |

**Remove & Replace Curb Ramp With Two New Directional Ramps or Equivalent.**

**R304.2.2, STD 1115**

Total Cost: \$ 6160
