# Access Compliance Report Public Rights-of-Way (Curb Ramps)

Main Street: **PIEDMONT\_AVE** Cross Street: **MARTHA\_ANN\_DR** Location: **S**

ADA ID: **RPAT211206111120** Ramp Type: **Type 1 - Perpendicular Diagonal** Initial Pass/Fail: **Pass** Overall Compliance: **No** Severity Score: **22**

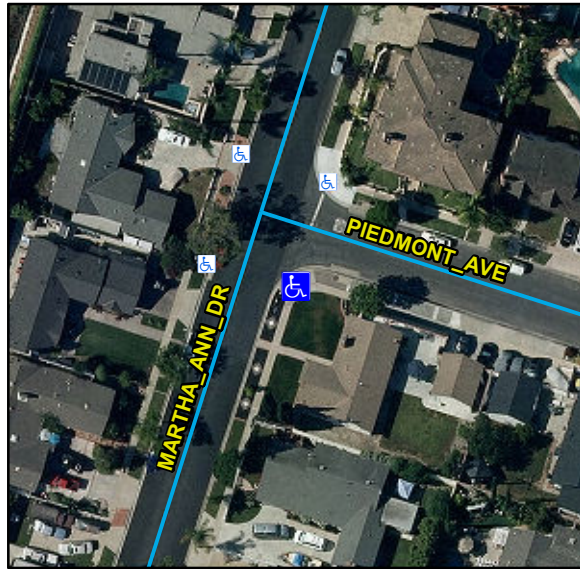
## Field Measurements/Component Compliance

| Compliance | Description | Data | Compliance | Description | Data |
|---|---|---|---|---|---|
| No | Landing Run Slope (%) | 2.2 | N/A | Flare Traversable RT | No |
| Yes | Landing Cross Slope (%) | 0.2 | No | DWS Provided | No |
| Yes | Gutter Ponding | No | No | Curb Slope | 9.1 |
| No | Gutter Run Slope (%) | 11.5 | | Road Cross Slope (%) | 3.3 |
| No | Gutter Cross Slope (%) | 2.6 | | | |

**Remove & Replace Curb Ramp With Two New Directional Ramps or Equivalent. Remove & Replace Gutter.**
