# Access Compliance Report Public Rights-of-Way (Curb Ramps)

Main Street: KENSINGTON\_RD Cross Street: PIEDMONT\_AVE Location: W

ADA ID: RPAT211206111542 Ramp Type: Type 1 - Perpendicular Diagonal Initial Pass/Fail: Pass Overall Compliance: No Severity Score: 23

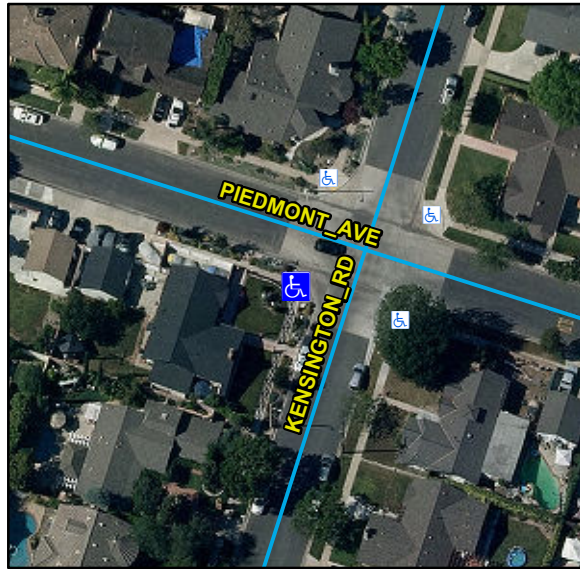
| Compliance | Description | Data | Compliance | Description | Data |
|---|---|---|---|---|---|
| No | Landing Run Slope (%) | 2.6 | N/A | Flare Traversable RT | No |
| Yes | Landing Cross Slope (%) | 1.1 | No | DWS Provided | No |
| N/A | Landing Movement Obstructed? | Yes | N/A | DWS Contrast | N/A |
| | Landing Movement Type | Fence | N/A | DWS Length (in) | N/A |
| No | Gutter Run Slope (%) | 7.3 | | Road Cross Slope (%) | 0.4 |
| No | Gutter Cross Slope (%) | 2.5 | | | |

Remove & Replace Curb Ramp With Two New Directional Ramps or Equivalent. Remove & Replace Gutter.
