# Access Compliance Report Public Rights-of-Way (Curb Ramps)

Main Street: **PIEDMONT\_AVE** Cross Street: **KENSINGTON\_RD** Location: **S**

ADA ID: **RPAT211206111856** Ramp Type: **Type 1 - Perpendicular Diagonal** Initial Pass/Fail: **Pass** Overall Compliance: **No** Severity Score: **2**

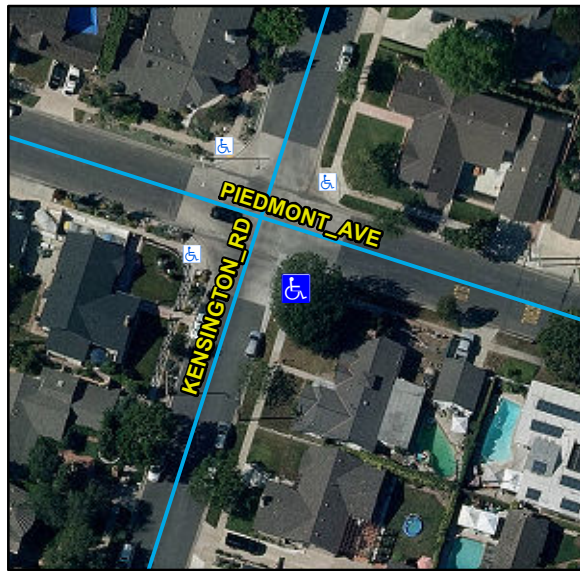
| Compliance | Description | Data | Compliance | Description | Data |
|---|---|---|---|---|---|
| <b>N/A</b> | Landing Length (in) | <b>49</b> | | | <b>Sloped</b> |
| <b>N/A</b> | Landing Movement Obstructed? | <b>Yes</b> | <b>Yes</b> | DWS Contrast | <b>Yes</b> |
| | Landing Movement Type | <b>Bushes</b> | <b>Yes</b> | DWS Length (in) | <b>36</b> |

**Remove & Replace Landing.**

**R304.2.1, STD 1115**

Total Cost: \$ **531**
