# Access Compliance Report Public Rights-of-Way (Curb Ramps)

Main Street: WEMBLEY\_RD Cross Street: PIEDMONT\_AVE Location: W

ADA ID: RPAT211206112404 Ramp Type: Type 1 - Perpendicular Diagonal Initial Pass/Fail: Pass Overall Compliance: Yes Severity Score: 0

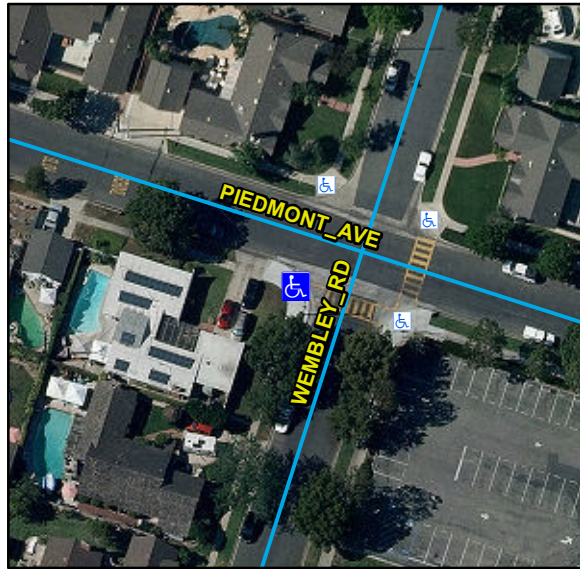
## Field Measurements/Component Compliance

| Compliance | Description | Data | Compliance | Description | Data |
|---|---|---|---|---|---|
| N/A | Ramp Length (in) | 76 | N/A | Flare Type LT | |
| Yes | Ramp Width (in) | 48 | | | Sloped |
| Yes | Ramp Run Slope (%) | 8 | N/A | Flare Slope LT (%) | 6.7 |
| Yes | Ramp Cross Slope (%) | 1.6 | N/A | Flare Traversable LT | No |
| Yes | Landing Width (in) | 49 | N/A | Flare Slope RT (%) | 6.9 |
| Yes | Landing Run Slope (%) | 0.8 | N/A | Flare Traversable RT | No |
| Yes | Landing Cross Slope (%) | 1.1 | Yes | DWS Provided | Yes |
