# Access Compliance Report Public Rights-of-Way (Curb Ramps)

| Main Street: FOSTER_RD | | Cross Street: PIEDMONT_AVE | | Location: | W |
| ADA ID: RPAT211206113418 | Ramp Type:Type 1 - Perpendicular Diagonal Initial Pass/Fail: Pass | | Overall Compliance: No | Severity Score: | 0 |

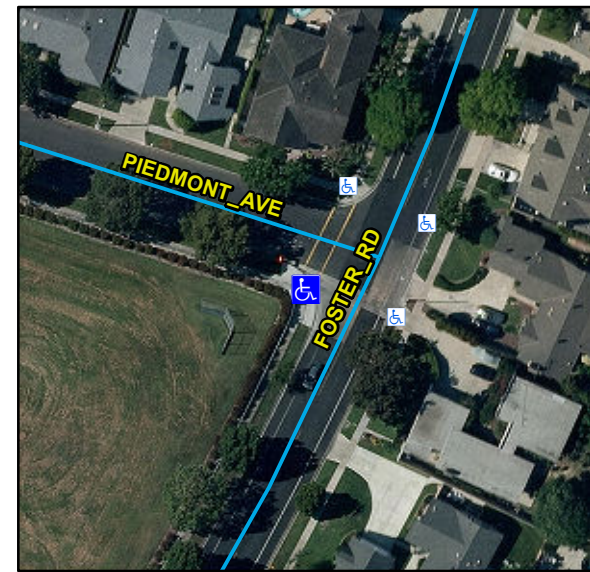
| Compliance | Description | Data | Compliance | Description | Data |
|---|---|---|---|---|---|
| No | Landing Run Slope (%) | 2.3 | N/A | Flare Traversable RT | No |
| No | Gutter Ponding | Yes | No | Curb Slope | 6.2 |

Remove & Replace Curb Ramp With Two New Directional Ramps or Equivalent.

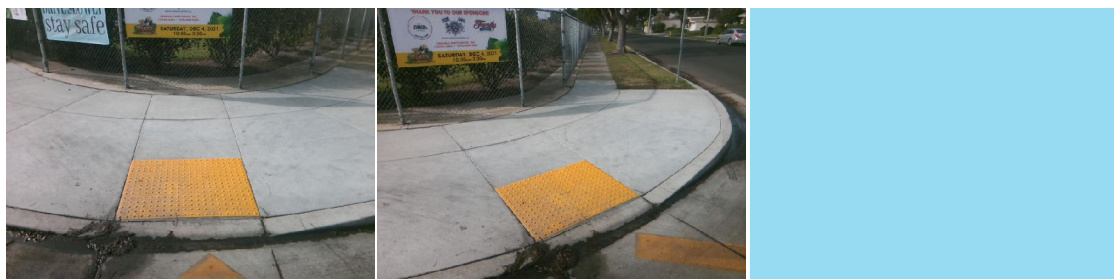
| Compliance | Description | Data | Compliance | Description | Data |
|---|---|---|---|---|---|
| N/A | Landing Movement Obstructed? | Yes | Yes | DWS Contrast | Yes |
| | Landing Movement Type | fence | Yes | DWS Length (in) | 36 |
