# Access Compliance Report Public Rights-of-Way (Curb Ramps)

Main Street: **PIEDMONT\_AVE** Cross Street: **FOSTER\_RD** Location: **N**

ADA ID: **RPAT211206113751** Ramp Type: **Type 1 - Perpendicular Diagonal** Initial Pass/Fail: **Pass** Overall Compliance: **No** Severity Score: **21**

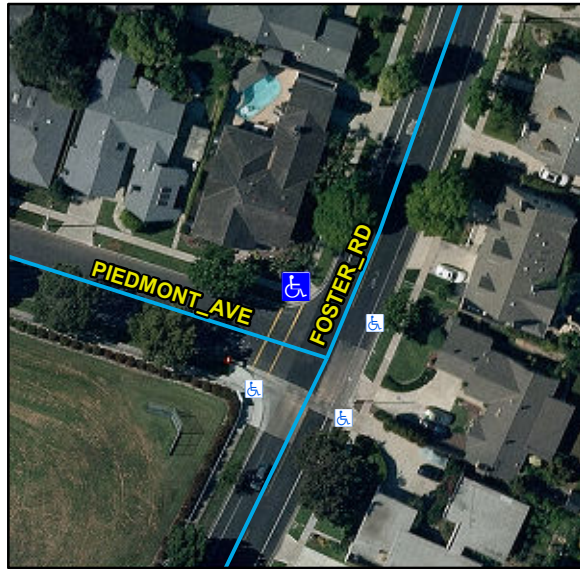
| Compliance | Description | Data | Compliance | Description | Data |
|---|---|---|---|---|---|
| No | Landing Run Slope (%) | 3.1 | N/A | Flare Traversable RT | No |
| Yes | Landing Cross Slope (%) | 0.7 | No | DWS Provided | No |
| No | Gutter Ponding | Yes | Yes | Curb Slope | 1.2 |
| No | Gutter Run Slope (%) | 6.5 | | Road Cross Slope (%) | 2.5 |

**Remove & Replace Curb Ramp With Two New Directional Ramps or Equivalent. Remove & Replace Gutter.**

**R204.3, R304.2.1, R304.2.2-Perp, R304.3.2-Para, R305, R302.7, R304.5.4, STD 1115**
