# Access Compliance Report Public Rights-of-Way (Curb Ramps)

Main Street: FOSTER\_RD Cross Street: CHANNING\_WAY Location: SW

ADA ID: RPAT211206114449 Ramp Type: Type 1 - Perpendicular Diagonal Initial Pass/Fail: Pass Overall Compliance: No Severity Score: 19

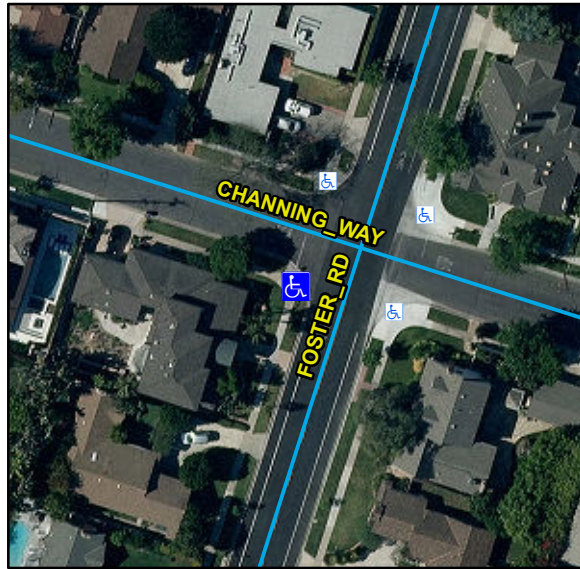
| Compliance | Description | Data | Compliance | Description | Data |
|---|---|---|---|---|---|
| Yes | Landing Cross Slope (%) | 1 | No | DWS Provided | No |
| Yes | Gutter Ponding | No | No | Curb Slope | 6.1 |
| No | Gutter Run Slope (%) | 5.6 | | Road Cross Slope (%) | 4.6 |

Remove & Replace Curb Ramp With Two New Directional Ramps or Equivalent. Remove & Replace Gutter.
