# Access Compliance Report Public Rights-of-Way (Curb Ramps)

Main Street: CHANNING\_WAY Cross Street: FOSTER\_RD Location: NW

ADA ID: RPAT211206114748 Ramp Type: Type 1 - Perpendicular Diagonal Initial Pass/Fail: Fail Overall Compliance: No Severity Score: 15

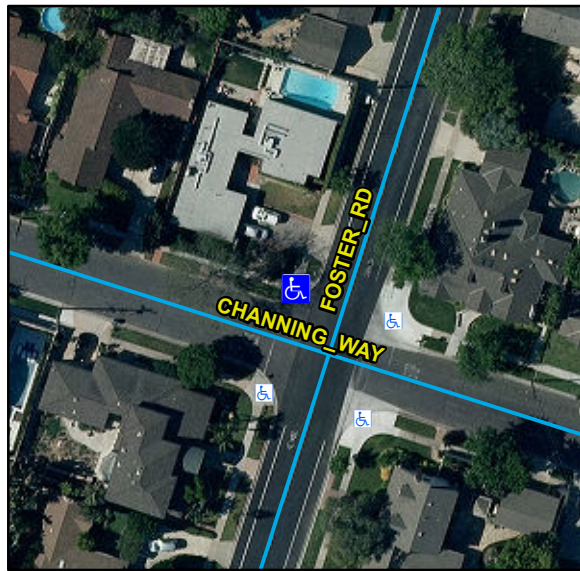
| Compliance | Description | Data | Compliance | Description | Data |
|---|---|---|---|---|---|
| No | Ramp Run Slope (%) | 8.5 | N/A | Flare Slope LT (%) | N/A |

Remove & Replace Curb Ramp With Two New Directional Ramps or Equivalent.

R204.3, R304.2.2, STD 1115
