# Access Compliance Report Public Rights-of-Way (Curb Ramps)

Main Street: FOSTER\_RD Cross Street: CHANNING\_WAY Location: NE

ADA ID: RPAT211206114949 Ramp Type: Type 1 - Perpendicular Diagonal Initial Pass/Fail: Pass Overall Compliance: No Severity Score: 0

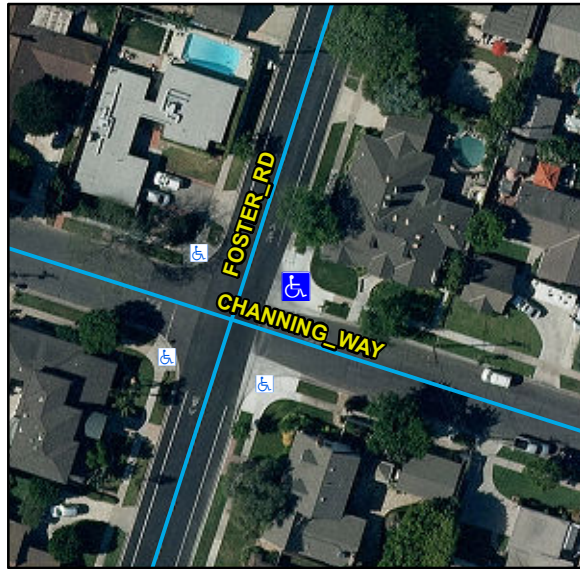
| Compliance | Description | Data | Compliance | Description | Data |
|---|---|---|---|---|---|
| No | Landing Run Slope (%) | 2.9 | N/A | Flare Traversable RT | No |

Remove & Replace Landing.

R304.2.2-Perp, R304.3.2-Para, STD 1115
