# Access Compliance Report Public Rights-of-Way (Curb Ramps)

Main Street: CHANNING\_WAY Cross Street: FOSTER\_RD Location: SE

ADA ID: RPAT211206115228 Ramp Type: Type 1 - Perpendicular Diagonal Initial Pass/Fail: Pass Overall Compliance: No Severity Score: 4

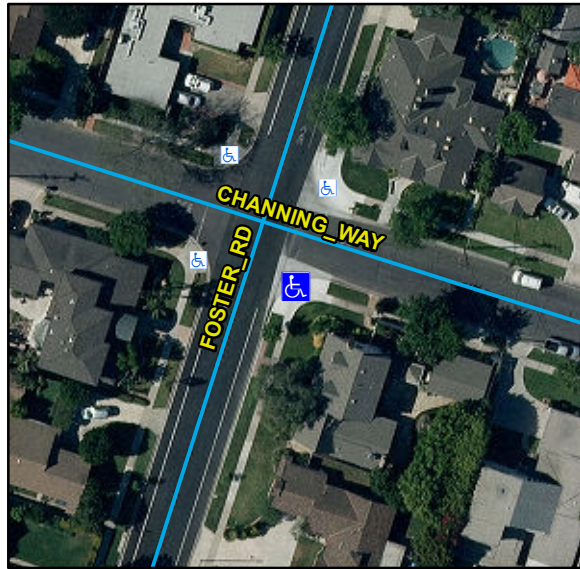
## Field Measurements/Component Compliance

| Compliance | Description | Data | Compliance | Description | Data |
|---|---|---|---|---|---|
| N/A | Landing Length (in) | 41 | | | Sloped |
| N/A | Landing Movement Obstructed? | Yes | Yes | DWS Contrast | Yes |
| | Landing Movement Type | Curb | Yes | DWS Length (in) | 36 |

Possible Solutions:

Remove & Replace Landing.

R304.2.1, STD 1115

Total Cost: \$ 531
