# Access Compliance Report Public Rights-of-Way (Curb Ramps)

Main Street: CHANNING\_WAY Cross Street: MARTHA\_ANN\_DR Location: S

ADA ID: RPAT211206122058 Ramp Type:Type 1 - Perpendicular Diagonal Initial Pass/Fail: Pass Overall Compliance: No Severity Score: 5

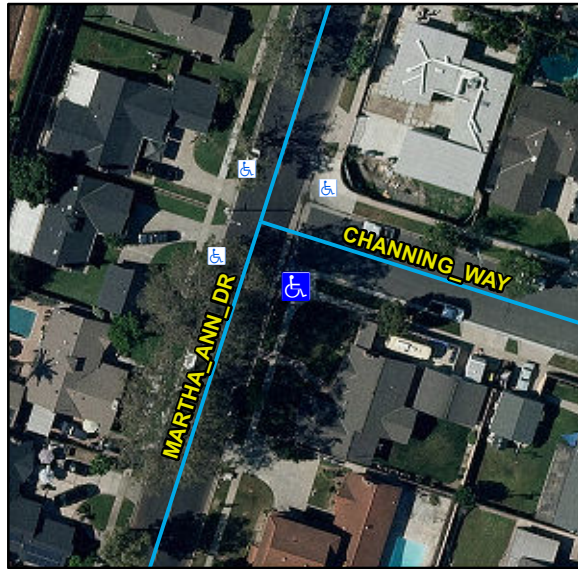
| Compliance | Description | Data | Compliance | Description | Data |
|---|---|---|---|---|---|
| No | Landing Run Slope (%) | 2.1 | N/A | Flare Traversable RT | No |
| Yes | Gutter Ponding | No | No | Curb Slope | 5.3 |
| No | Gutter Run Slope (%) | 8 | | Road Cross Slope (%) | 0.6 |

Remove & Replace Curb Ramp With Two New Directional Ramps or Equivalent. Remove & Replace Gutter.
