# Access Compliance Report Public Rights-of-Way (Curb Ramps)

Main Street: MARTHA\_ANN\_DR Cross Street: ST\_ALBANS\_DR Location: E

ADA ID: RPAT211206125034 Ramp Type: Type 1 - Perpendicular Diagonal Initial Pass/Fail: Fail Overall Compliance: No Severity Score: 15

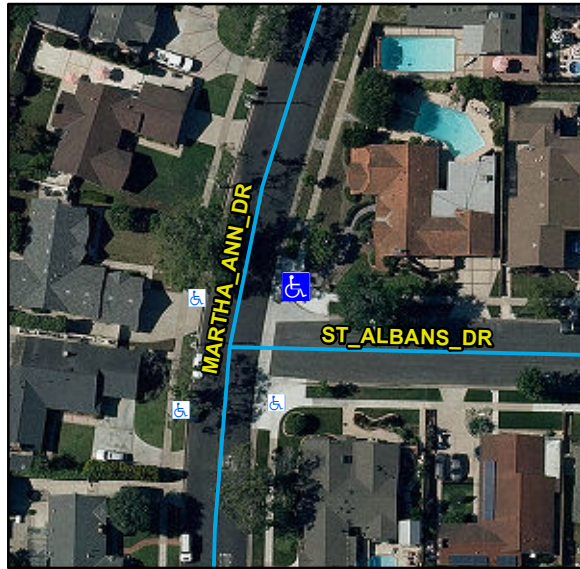
| Compliance | Description | Data | Compliance | Description | Data |
|---|---|---|---|---|---|
| No | Ramp Run Slope (%) | 8.8 | N/A | Flare Slope LT (%) | N/A |

Remove & Replace Curb Ramp With Two New Directional Ramps or Equivalent.

R304.2.2, STD 1115
