# Access Compliance Report Public Rights-of-Way (Curb Ramps)

Main Street: MARTHA\_ANN\_DR Cross Street: OAK\_KNOLL\_DR Location: NE

ADA ID: RPAT211206125438 Ramp Type: Type 1 - Perpendicular Diagonal Initial Pass/Fail: Pass Overall Compliance: No Severity Score: 19

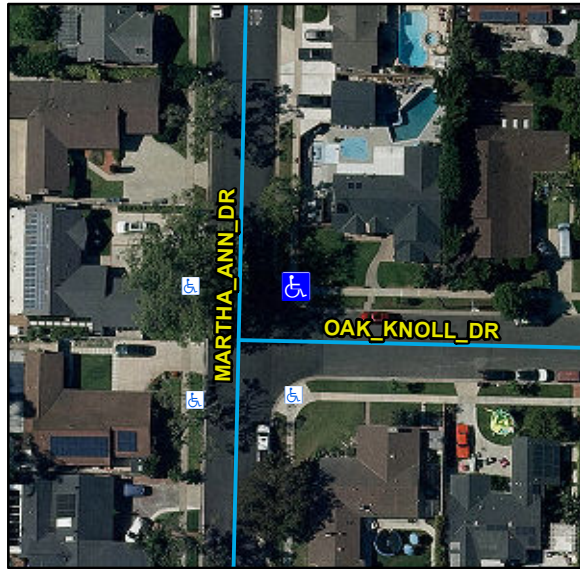
| Compliance | Description | Data | Compliance | Description | Data |
|---|---|---|---|---|---|
| Yes | Landing Cross Slope (%) | 0.6 | No | DWS Provided | No |
| Yes | Gutter Ponding | No | No | Curb Slope | 6.7 |
| No | Gutter Run Slope (%) | 12.5 | | Road Cross Slope (%) | 2.7 |
| No | Gutter Cross Slope (%) | 2.7 | | | |

Remove & Replace Curb Ramp With Two New Directional Ramps or Equivalent. Remove & Replace Gutter.

R304.2.2, R204.3, R304.2.1, R305, R304.5.4, R304.5.3, STD 1115

Total Cost: \$ 6412
