# Access Compliance Report Public Rights-of-Way (Curb Ramps)

Main Street: OAK\_KNOLL\_DR Cross Street: MARTHA\_ANN\_DR Location: SE

ADA ID: RPAT211206125821 Ramp Type: Type 1 - Perpendicular Diagonal Initial Pass/Fail: Fail Overall Compliance: No Severity Score: 16

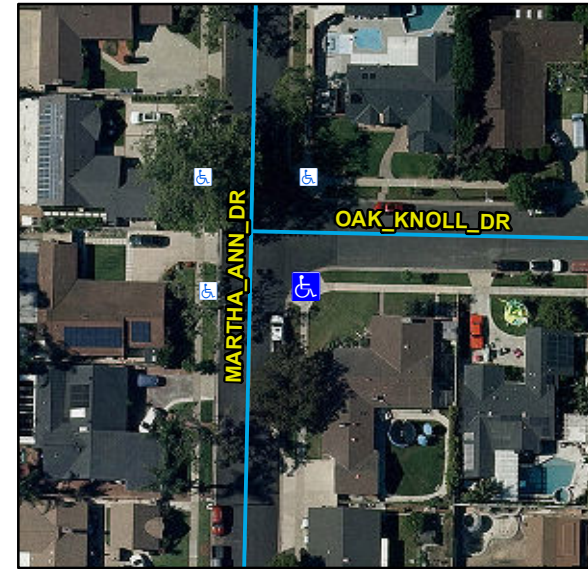
| Compliance | Description | Data | Compliance | Description | Data |
|---|---|---|---|---|---|
| No | Ramp Run Slope (%) | 8.5 | N/A | Flare Slope LT (%) | N/A |

Possible Solutions:  
**Remove & Replace Curb Ramp With Two New Directional Ramps or Equivalent.**

OC Std/PROW:  
**R204.3, R304.2.2, STD 1115**
