# Access Compliance Report Public Rights-of-Way (Curb Ramps)

Main Street: MARTHA\_ANN\_DR Cross Street: WOODSTOCK\_RD Location: NE

ADA ID: RPAT211206130134 Ramp Type: Type 1 - Perpendicular Diagonal Initial Pass/Fail: Pass Overall Compliance: No Severity Score: 16

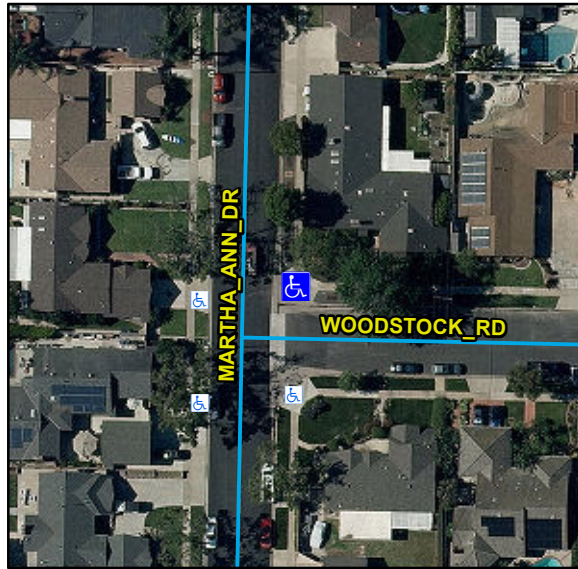
| Compliance | Description | Data | Compliance | Description | Data |
|---|---|---|---|---|---|
| No | Landing Run Slope (%) | 2.7 | N/A | Flare Traversable RT | No |
| Yes | Landing Cross Slope (%) | 0.4 | No | DWS Provided | No |
| Yes | Gutter Ponding | No | No | Curb Slope | 8.5 |

Remove & Replace Curb Ramp With Two New Directional Ramps or Equivalent.
