# Access Compliance Report Public Rights-of-Way (Curb Ramps)

Main Street: WOODSTOCK\_RD Cross Street: MARTHA\_ANN\_DR Location: SE

ADA ID: RPAT211206130441 Ramp Type: Type 1 - Perpendicular Diagonal Initial Pass/Fail: Pass Overall Compliance: No Severity Score: 16

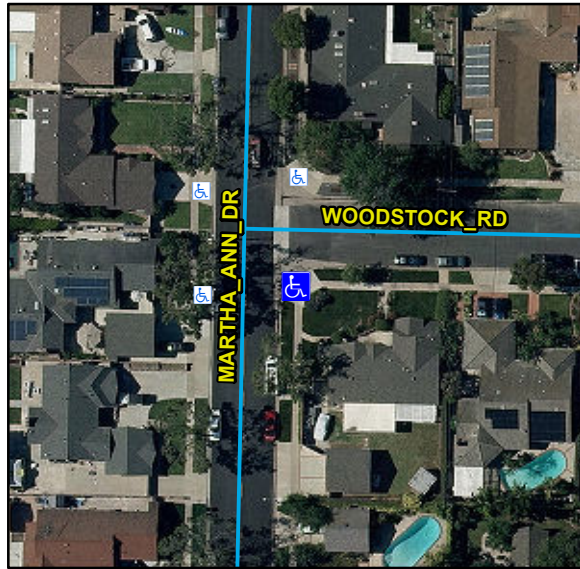
| Compliance | Description | Data | Compliance | Description | Data |
|---|---|---|---|---|---|
| Yes | Landing Cross Slope (%) | 0.9 | No | DWS Provided | No |
| Yes | Gutter Ponding | No | No | Curb Slope | 8.3 |

Remove & Replace Curb Ramp With Two New Directional Ramps or Equivalent.

R304.2.2, R204.3, R304.2.1, R305, STD 1115
