# Access Compliance Report Public Rights-of-Way (Curb Ramps)

| Main Street: OAK_KNOLL_DR | | Cross Street: ARGYLE_DR | | Location: | SE |
| ADA ID: RPAT211206132113 | Ramp Type:Type 1 - Perpendicular Diagonal Initial Pass/Fail: Fail | | Overall Compliance: No | Severity Score: | 15 |

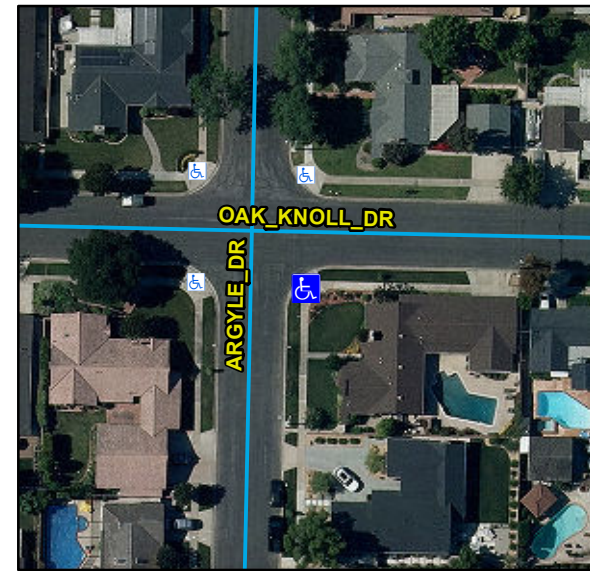
| Compliance | Description | Data | Compliance | Description | Data |
|---|---|---|---|---|---|
| No | Ramp Run Slope (%) | 8.4 | N/A | Flare Slope LT (%) | N/A |
| N/A | Gutter Ponding | N/A | No | Curb Slope | 9.3 |

**Remove & Replace Curb Ramp With Two New Directional Ramps or Equivalent.**

**R304.2.2, R204.3, STD 1115**

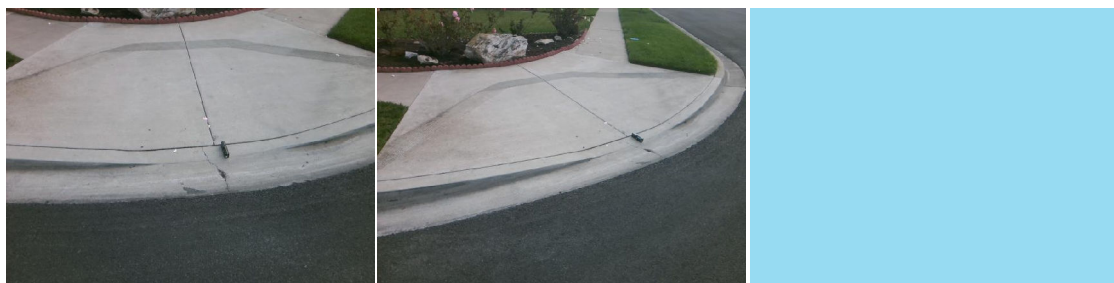
| Compliance | Description | Data | Compliance | Description | Data |
|---|---|---|---|---|---|
| N/A | Ramp Length (in) | 82 | N/A | Flare Type LT | |
| Yes | Ramp Width (in) | 55 | | | N/A |
| Yes | Ramp Cross Slope (%) | 0.4 | N/A | Flare Traversable LT | N/A |
