# Access Compliance Report Public Rights-of-Way (Curb Ramps)

Main Street: ARGYLE\_DR Cross Street: OAK\_KNOLL\_DR Location: NE

ADA ID: RPAT211206132321 Ramp Type: Type 1 - Perpendicular Diagonal Initial Pass/Fail: Fail Overall Compliance: No Severity Score: 15

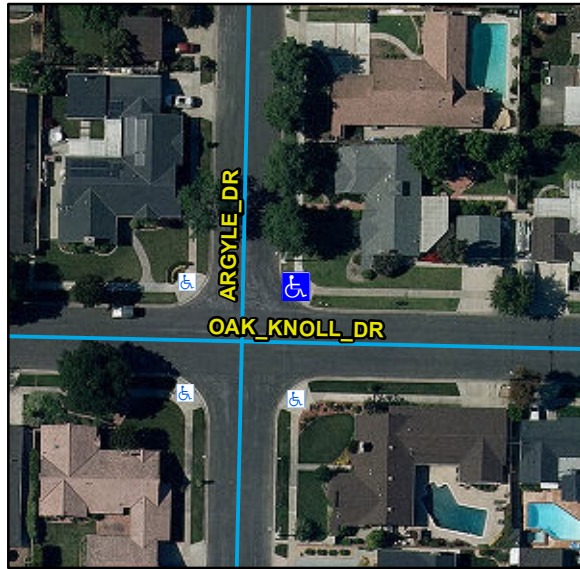
| Compliance | Description | Data | Compliance | Description | Data |
|---|---|---|---|---|---|
| No | Ramp Run Slope (%) | 8.8 | N/A | Flare Slope LT (%) | N/A |

**Remove & Replace Curb Ramp With Two New Directional Ramps or Equivalent.**

**R304.2.2, R204.3, STD 1115**
